Safety Alert

Subject: Flat Webbing Slings – two layer sling with reinforced eyes (Duplex)

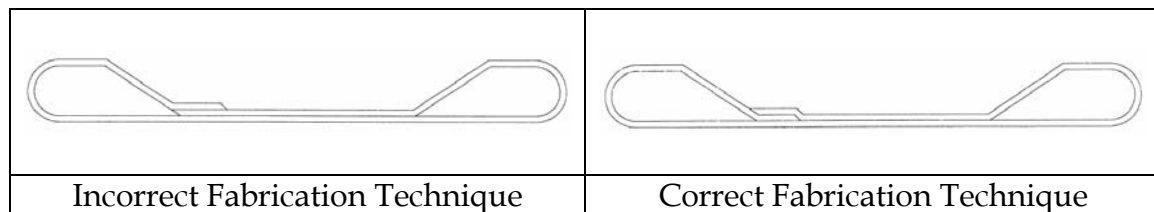
- The construction of the slings does not comply with BS EN1492-1 Table 2 (see diagrams below)
- The seams were irregular (rucked) along portions of their length.
- The reinforcement material applied to the eyes covers only 15% of the eye.

After having conducted the tests on slings fabricated by Manufacturer A, we conducted another test on a sling from a different Manufacturer (B). Despite the tails being correctly ordered, the sling from the second manufacturer also failed below the required MBL.

- Check the fabrication method and if incorrect manufacturing technique is found, return immediately to the supplier (and inform one of the undernoted personnel).
- If manufacturing method appears to be correct, quarantine until further information is available.

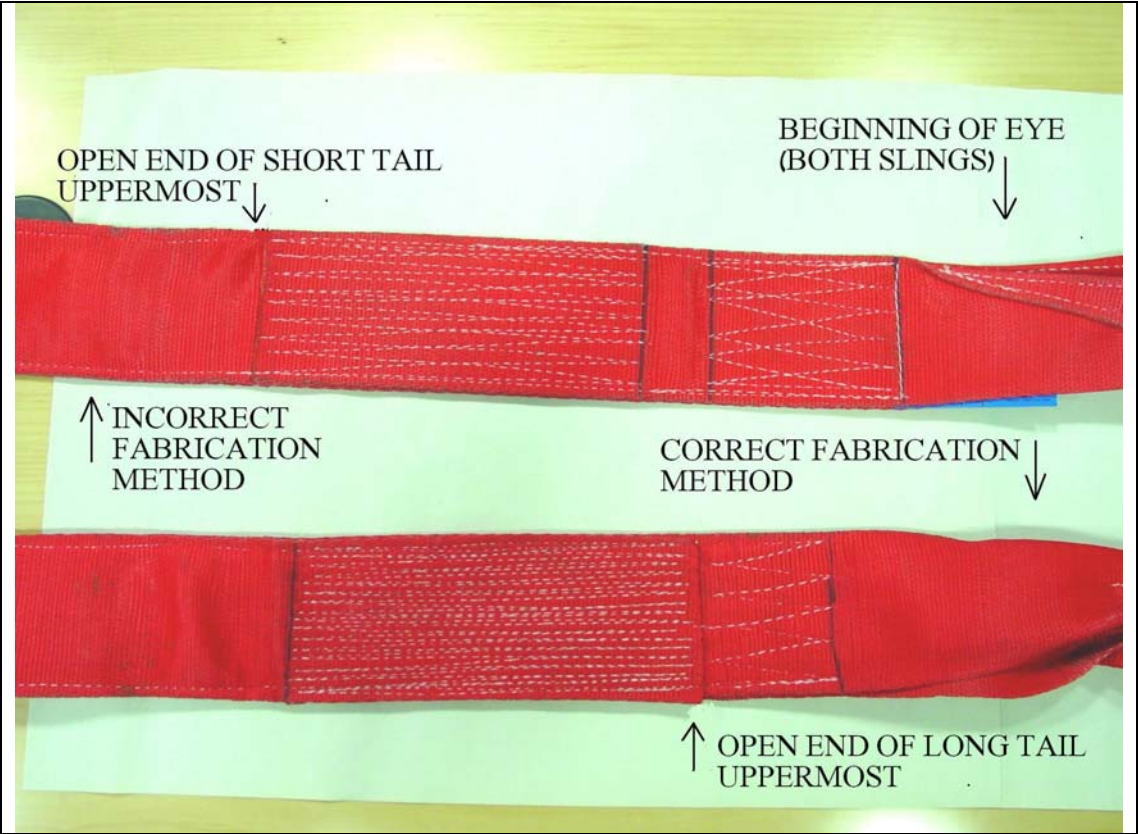
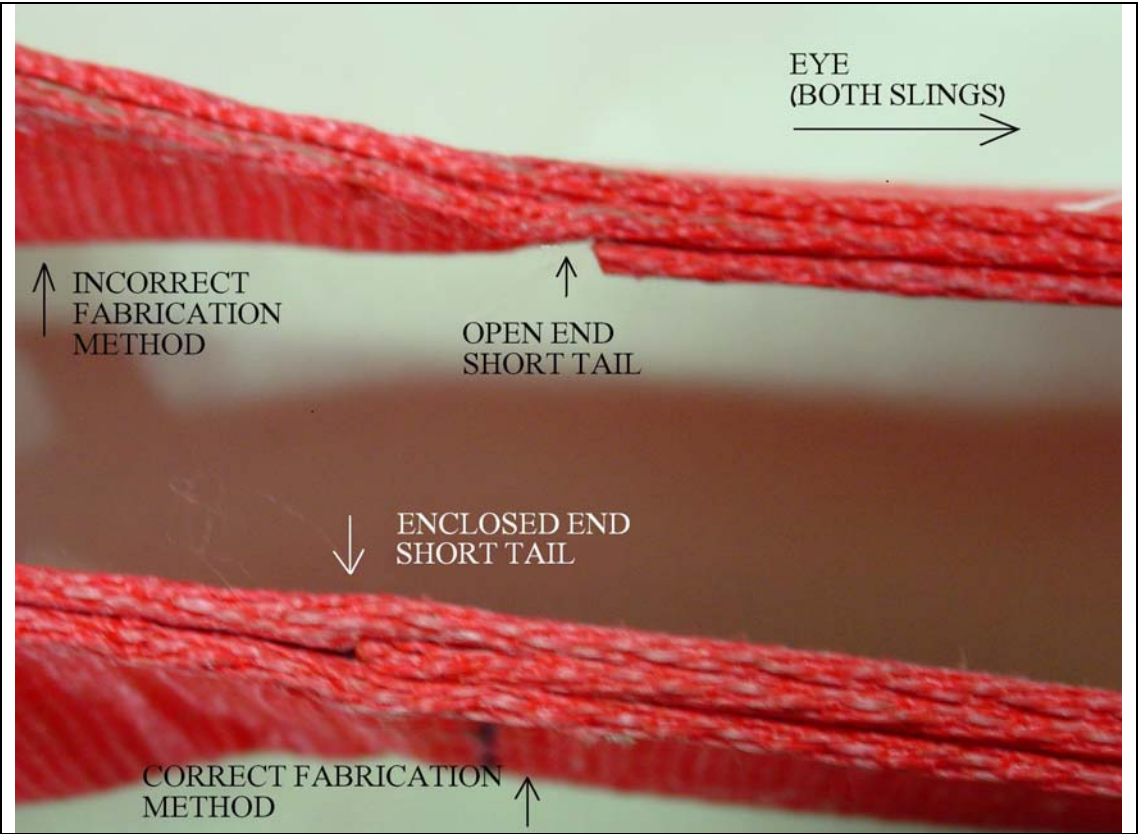
As a result of conducting tests on flat (duplex) webbing slings, we have become aware that some slings have been incorrectly fabricated. A duplex sling has a “short tail” and a “long tail”. The correct fabrication method is to have the short tail captured between the long tail and what would be the single layer of a Simplex sling. See sketches at the bottom of this page and photographs on following page. However, a number of slings (quantity currently unknown) have been fabricated with the short tail uppermost.

Photographs below show the tail overlap portions of an incorrectly manufactured sling and a correctly manufactured sling.
